# Spot the Hazards

WORK **SAFE BC**

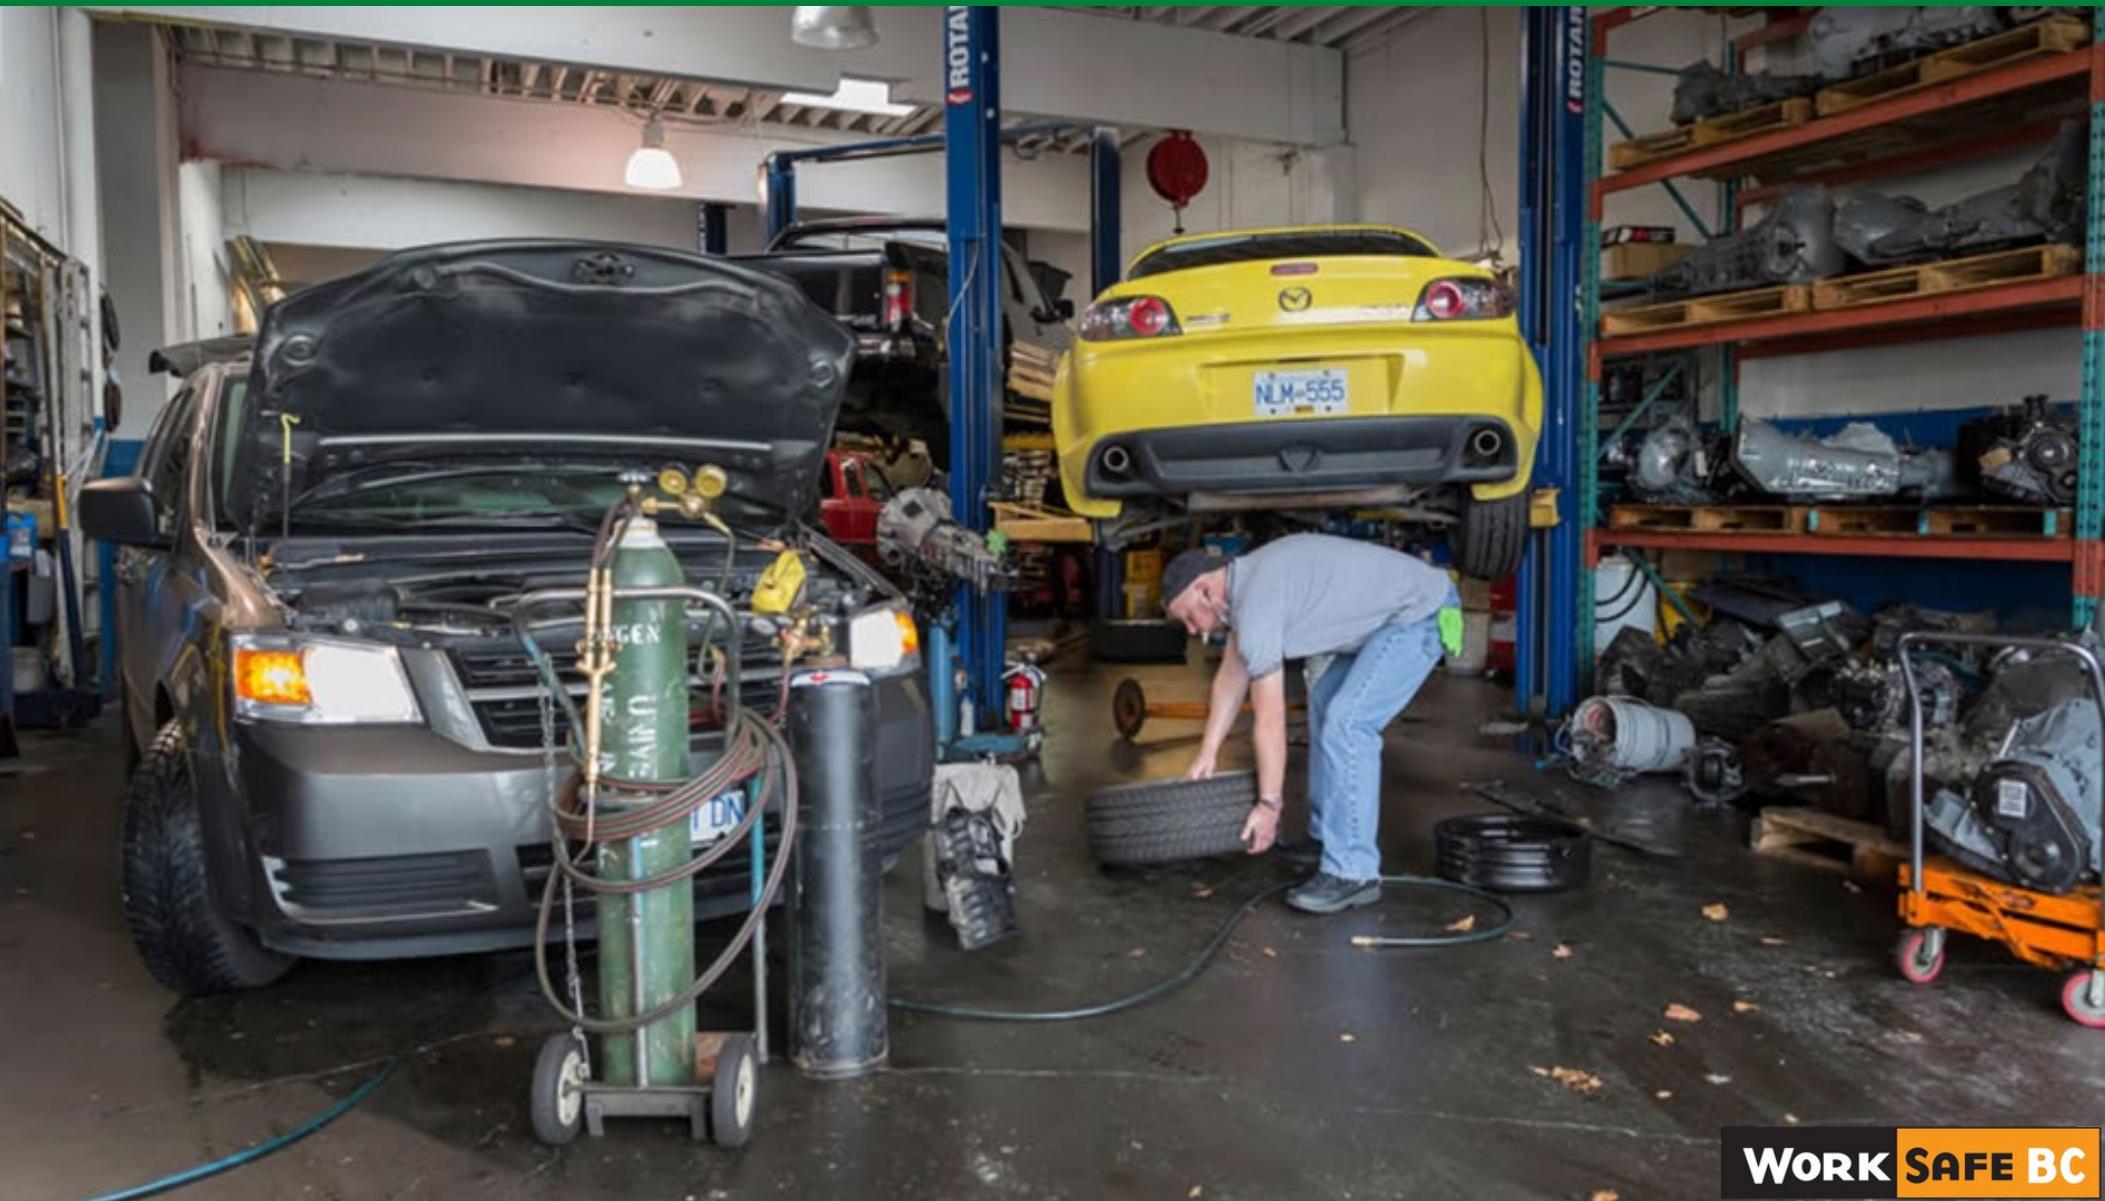
The angle of the yellow car suggests a potentially hazard defect in the lift.

No emergency washing facility seems to be in the area.

- The worker appears to be working alone and is smoking in the workplace.
- The position the worker's in to lift the tire isn't ergonomic.
- The worker is positioned under the raised vehicle.

The minivan is running, as evidence by the daytime running lights; no venting system is available to safely redirect exhaust gases outdoors.

The fire extinguisher is on the floor.

An oil collection pan (possibly containing transmission fluid) is directly behind the worker.

The cylinder of compressed gas is not secured.

The air hose is a tripping hazard.
