Spot the Hazards

WORK SAFE BC

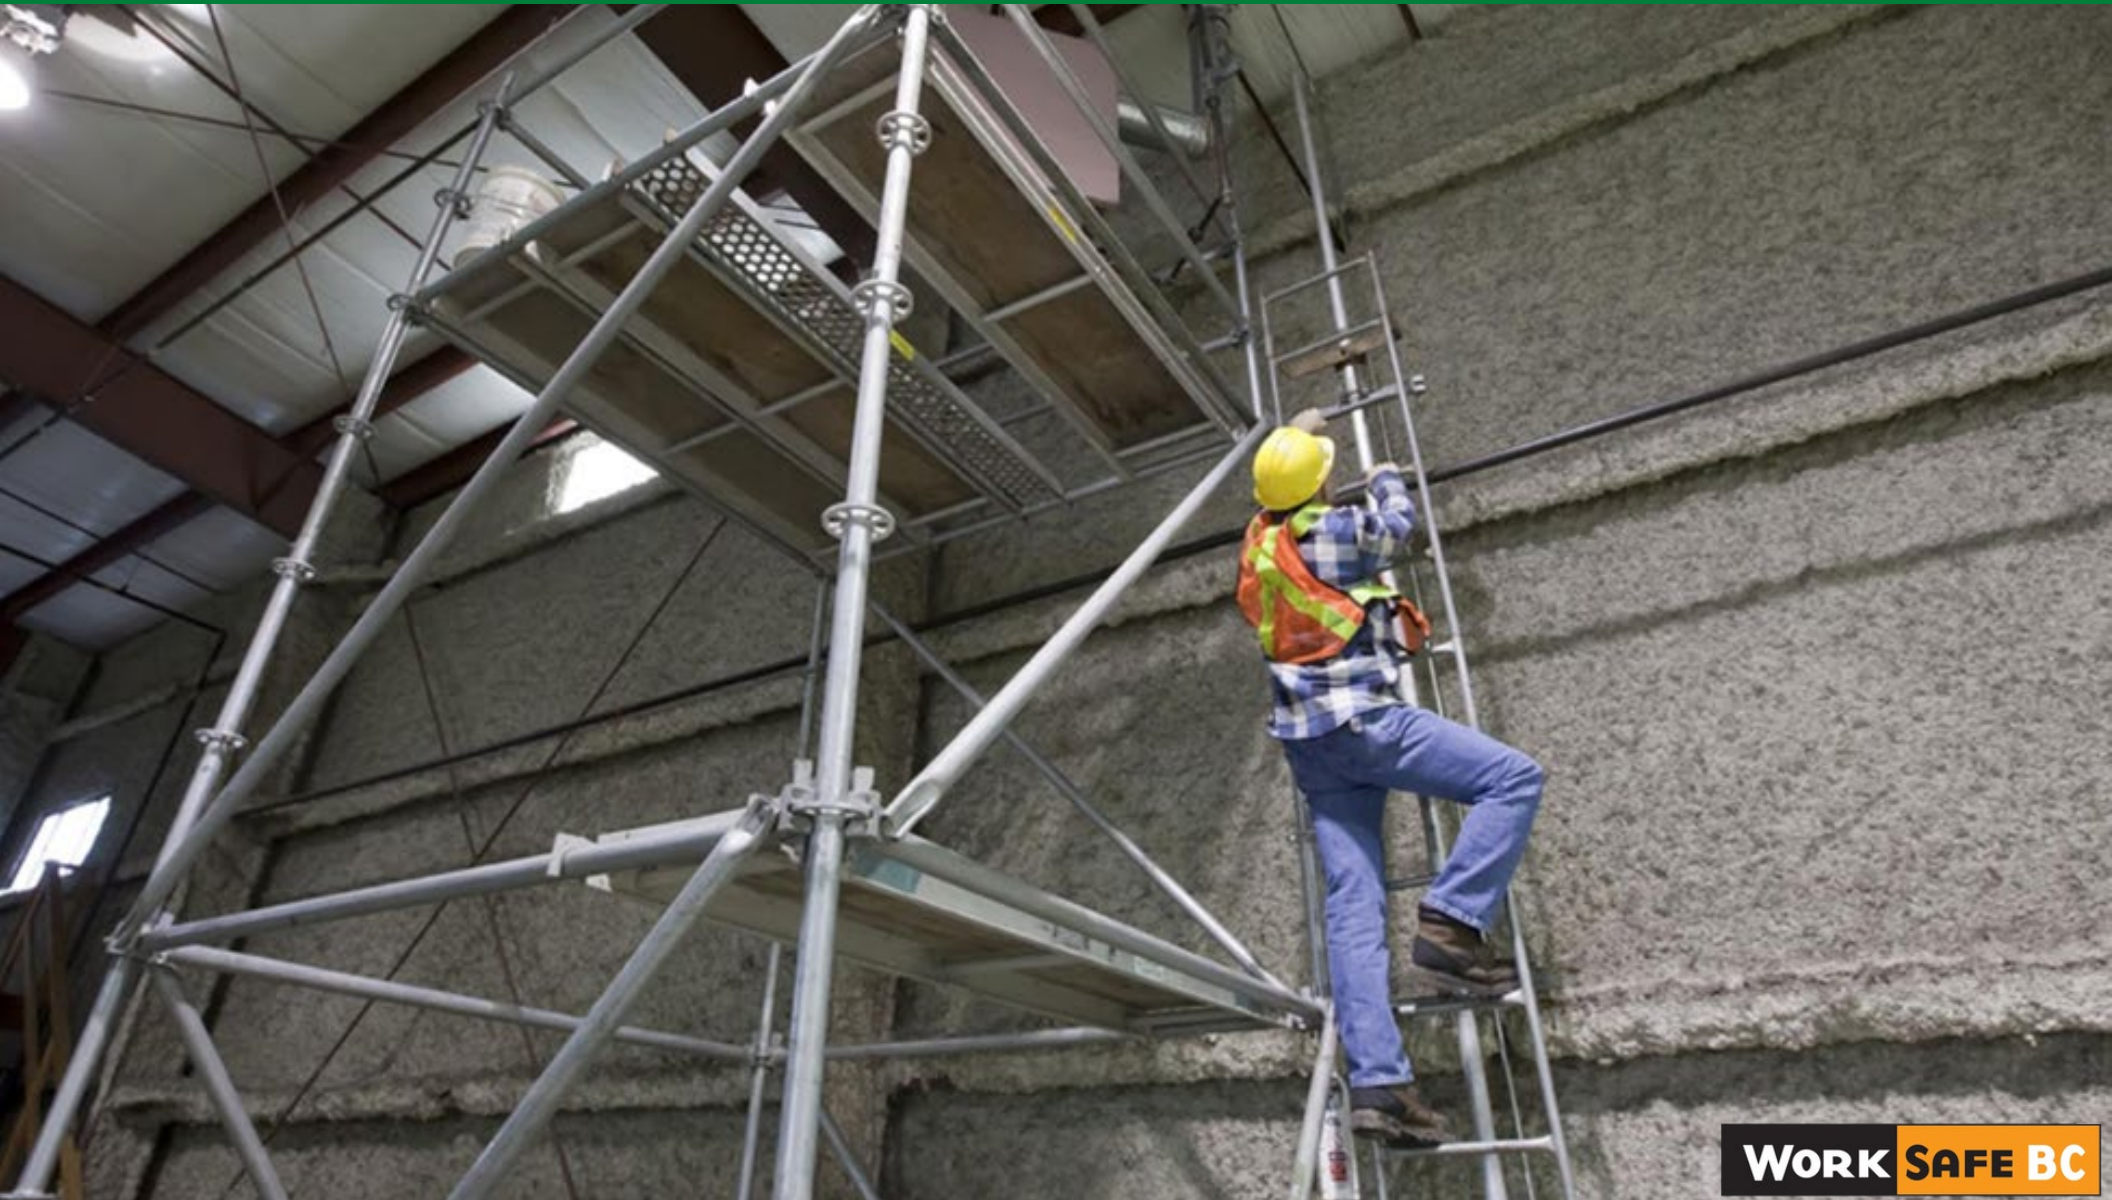
There should be a mid-rail and toe board on the scaffold.

There is a bucket near the edge.

There is a dangerous gap in the middle of the upper level platform

The worker doesn't have safe access to the lower or upper levels of the scaffold (they would have to crawl through the brace and guard rails to reach it).

The access ladder is too short (it must be long enough to project approximately 1 m (3 ft.) above the upper landing to which it provides access).

Worker isn't wearing any fall protection.

The lower level platform is unfinished. There must be a guardrail present in order to use it.

The scaffold has a lockout tag, indicating that it shouldn't be used.
