Spot the Hazards

WORK SAFE BC

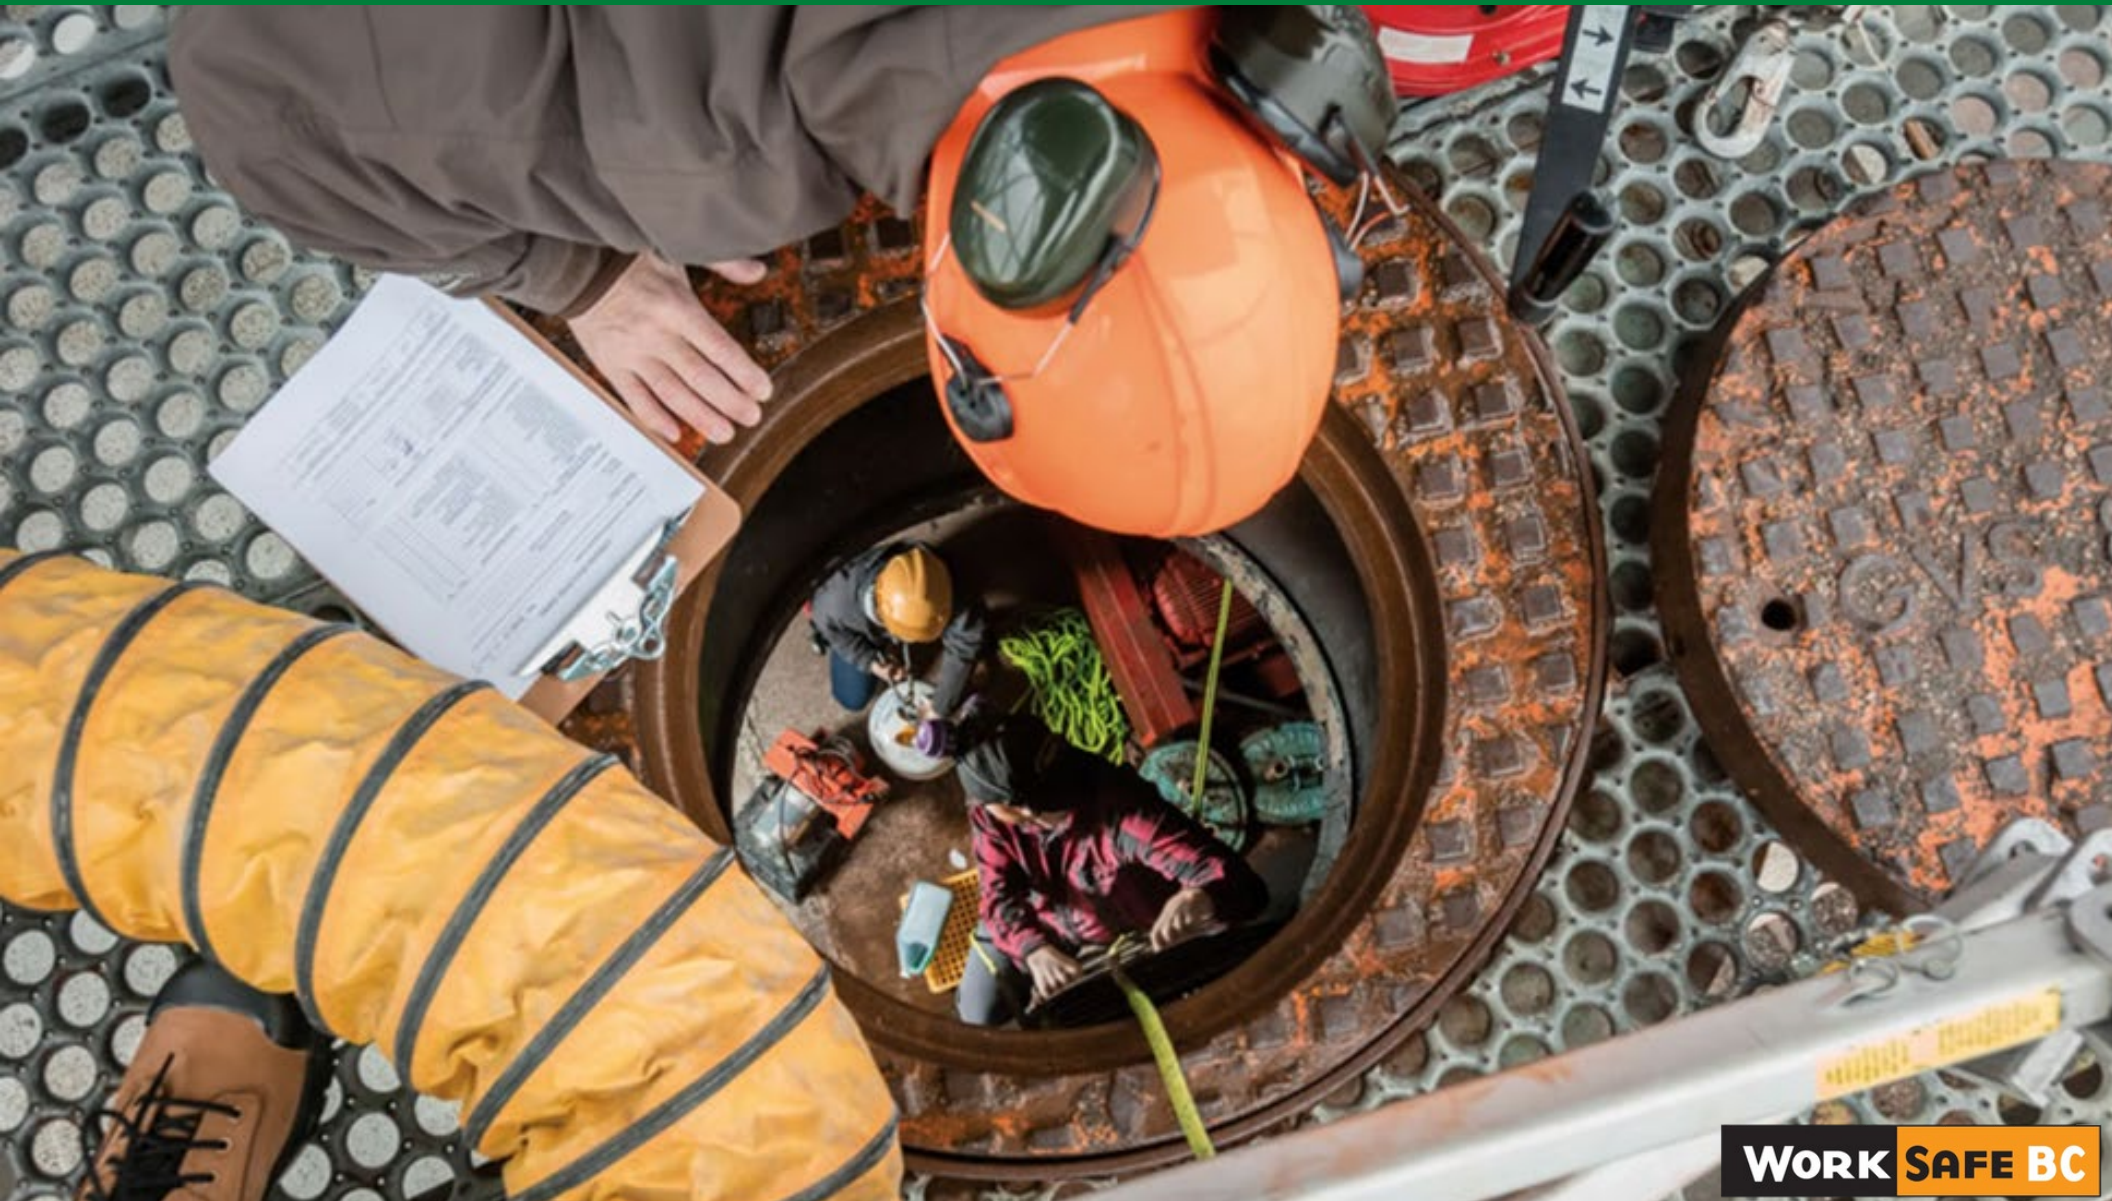
The entry permit hasn't been filled out or signed, and is missing atmospheric testing data.

The worker is using a wrench to tighten what looks like a propane canister. Containers of fuels such as gasoline or propane should not be taken into a confined space.

This worker is breaking protocol by crossing the plane of entry, they're potentially breathing in toxic air by having their face over the hole.

Lifting equipment is present but not set up, and therefore would not be helpful in an urgent emergency.

There's a rope but it's not set up for rescue purposes. The excess rope at the bottom is a tripping hazard.

This worker is not wearing a hard hat.

The mechanical fan system is located inside the confined space and not connected to the ducting; if it's turned on, it will only create turbulence in the space and will not provide fresh air. It is also a potential ignition source

The ventilation duct is not connected to the confined space or the mechanical fan system
